Case study

Failure analysis of a vibration isolator used in launch vehicle applications

Material Characterization Division, Materials and Metallurgy Group, Vikram Sarabhai Space Centre, Trivandrum 695 022, India

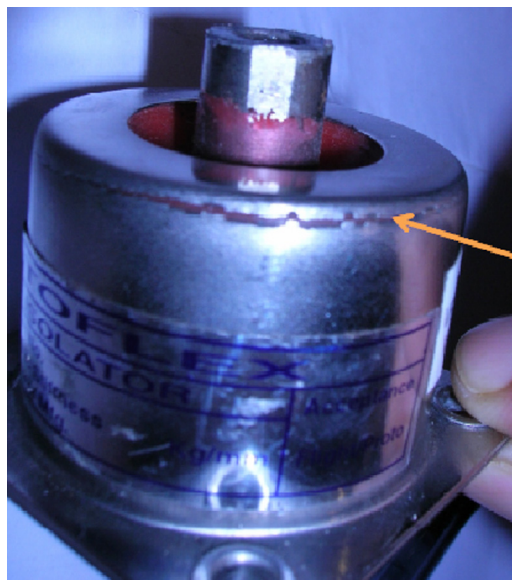
The chemical composition of the failed vibration isolation body corresponds to AISI 304 austenitic stainless steel. The chemical composition in weight percentage is: Cr-16.9; Ni-8.29; Mn-1.15; V-0.078; Mo-0.1 and Fe-Balance. Fig. 1 shows the cracked vibration isolator with the elastomer in place. Visual observations were carried out on the failed vibration isolator. The cracked vibration isolator had a crack of length approximately 42 mm at the fore end corner. The crack was wide at center and had a zig-zag profile (Fig. 1). About 10 mm from the top of the body where crack was noticed, there exists a circumferentially dull region, due to severe plastic straining. Below, it is bright and shining. Inside surface has die marks along the height of the body.

Fig. 1. Vibration isolator assembly with molded insert in place.

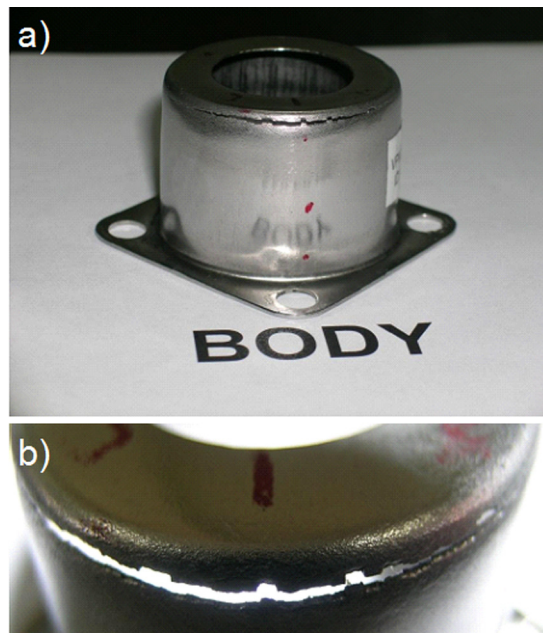
Fig. 2 shows the full body (Fig. 2(a)) of the vibration isolator along with the close up view of the crack (Fig. 2(b)). It can be seen from Fig. 2(b) that the surface at the location of the cracks has a mat finish showing plastic deformation. The cracked portion at the fore end corner was sectioned carefully in a Buehler make Isomet slow speed saw. Fig. 3(a) shows the low magnification scanning electron micrograph of the cracked surface showing zig-zag crack path and Fig. 3(b) shows the

Fig. 2. (a) Cracked vibration isolator body and (b) close-up view of the same showing zig-zag crack path and matted surface finish near to the corner area.

The chemical composition of the failed vibration isolator corresponds to AISI 304. The dull appearance at the fore end region and low thickness (of 0.4 mm against the 0.8 mm indicated in the drawing) at the location of crack indicates that the deep drawing operation resulted in large strains at the fore end corner. The hardness at the location of crack is also significantly higher compared to the successfully tested and untested isolators. This is in agreement with the severe thinning observed at the location of failure. The component has not undergone any stress relieving operation during or after forming. So the presence of residual stresses is also significant.

Multiple micro-cracks were noticed near to the location of crack and running parallel to the length of the crack. The zig-zag nature of the crack path (Fig. 2(b)) indicates that these micro cracks have joined together resulting in the failure of the vibration isolator during vibration testing. This is corroborated by the fact that many vibration isolators fabricated with the same die set and processed under similar processing plan have been successfully used. This eliminates the possibility of problems related to the die design or processing. However, the hardness of the material near to the location of crack along with large thinning observed indicated that the material used for the fabrication of the component was not in fully annealed condition. Therefore, it is recommended to use deep drawing grade material in fully annealed condition to avoid the recurrence of such failures.

Based on the above inferences, it can be concluded that micro cracks formed during the deep drawing operation (due to large strains at the fore end corner) propagated during vibration testing resulting in the cracking of the body of the vibration isolator. It is recommended to use the material in fully annealed condition to avoid cracking during deep drawing operations involving no intermediate annealing steps.

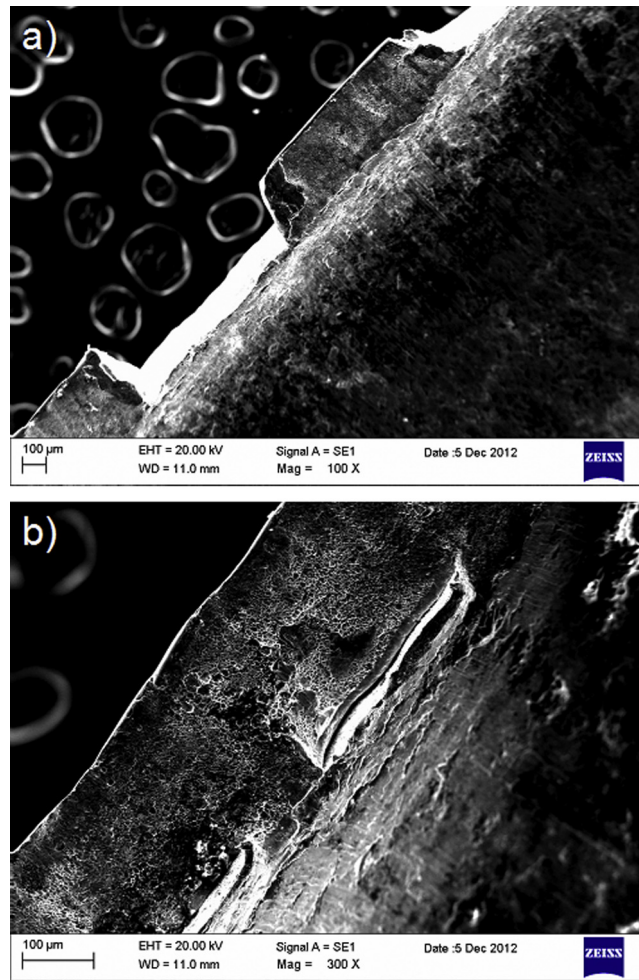
presence of microcracks near to the location of failure. The thickness at the location of crack is about 0.4 mm taken at several locations along the crack length. These microcracks could be seen along the periphery of the crack and parallel to the main crack. Fig. 4 shows the scanning electron micrograph of the surface cracked vibration isolator showing dimples throughout the surface. Dimples are shallow and are elongated indicating that the microstructure is highly deformed at the location of failure. Fig. 5 shows the optical microstructures of the 0.8 mm thick raw material sheet taken on the surface which was used for the fabrication of vibration isolator. The microstructure shows typical austenitic grains with twins on the surface of the material. The polished and etched cross section (Fig. 5(b)) shows strain markings along the direction of rolling indicating that the sheet has not been fully annealed.

Fig. 3. (a) Scanning electron micrograph of the cracked vibration isolator showing zig-zag crack path and (b) presence of microcracks at the location of failure.

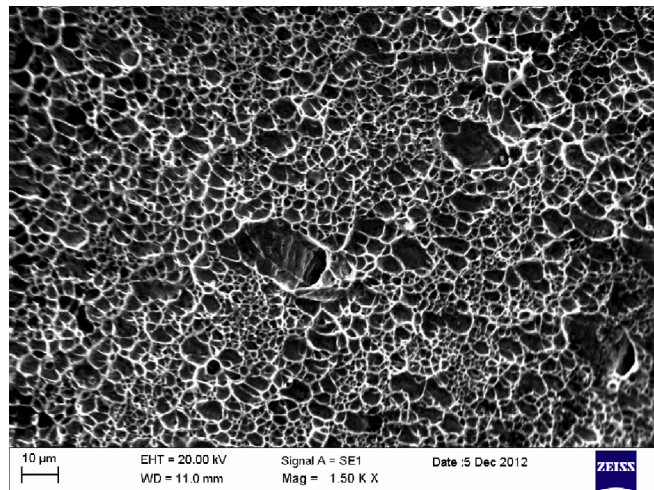
Fig. 4. Scanning electron micrograph of the cracked vibration isolator showing dimpled failure.

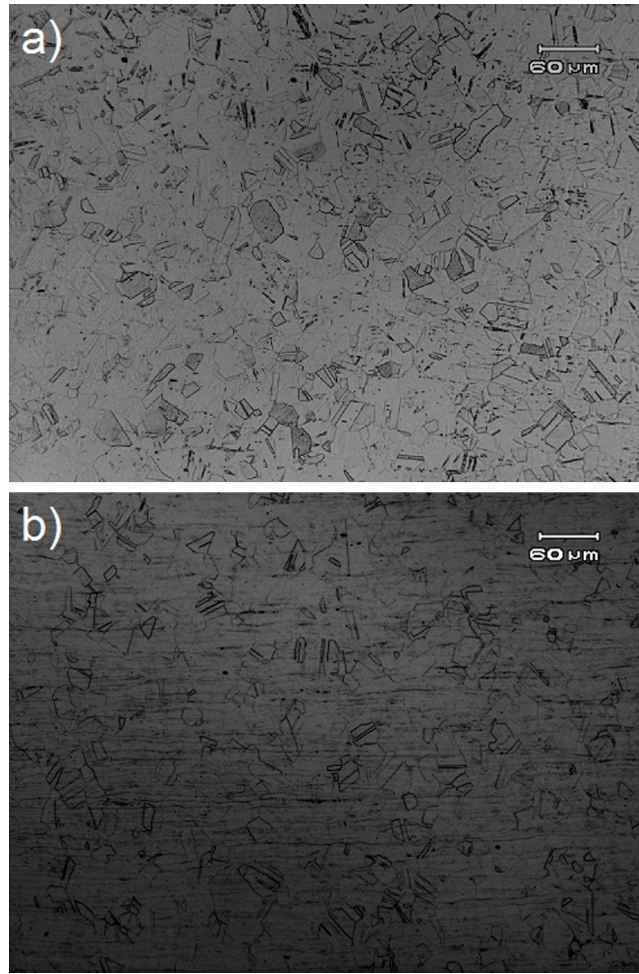
Optical microscopic observations revealed typical austenitic structure in the raw material used for the fabrication of vibration isolator. However, deformation induced martensite was noticed in the body of the cracked specimen (as well as untested and successfully tested components supplied) along the height. Austenitic stainless steel AISI 304 being a metastable steel, deformation induced martensite is expected during forming operations. Microhardness results indicate significantly higher hardness for the cracked specimen at the location of failure (425 VPN) compared to 338 VPN (un failed after testing) and 387 VPN (un used). The ferrite number (FN) measurement conducted on the cracked vibration isolator near to the crack was 22 FN. The ferrite numbers on unfailed vibration isolator at same location was 10 FN. However, the ferrite

Fig. 5. Optical microstructures of the raw material used for the fabrication of vibration isolator (a) showing austenitic grains with twins on the surface of the material and (b) strain markings on the cross section.

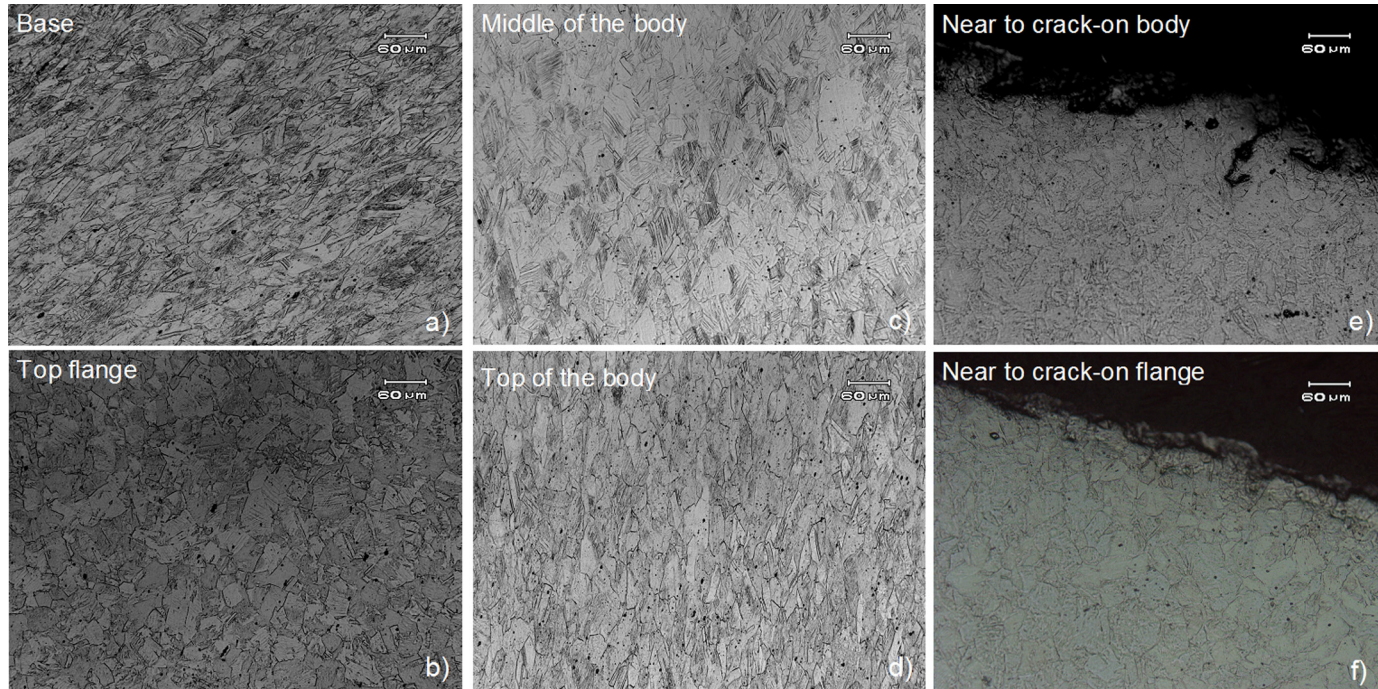
Fig. 6(a–f) shows the optical photomicrographs obtained from base, top flange, middle of the body and top of the body and near to crack on both sides of the body and flange of the cracked vibration isolator. The presence of deformation induced martensite at middle and top of the body of the isolator with the original grains deformed during the deep drawing operation can be clearly noticed. During deep drawing operation, the material is subjected to loads beyond the yield strength of the material to induced shape change. The strains that get introduced into the material will vary the microstructure accordingly. In the present case, the strain introduces martensitic transformation in the material which can be clearly seen in the photomicrographs taken along the height of the vibration isolator.

Fig. 6. (a–f) Optical photomicrographs obtained from different regions of the cracked vibration isolator. Note the presence of deformation induced martensite.

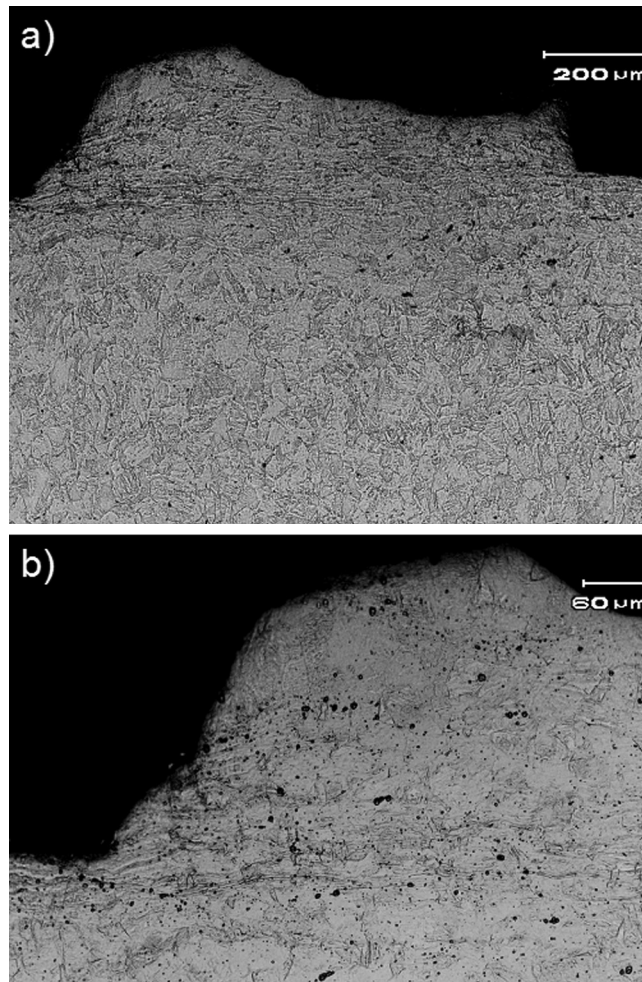
Fig. 7. Optical photomicrographs taken at the crack edge of the failed vibration isolator. Note the presence of deformation induced martensite and deformed grains in the radial direction taken at two different magnifications (a and b).

Strain induced martensitic transformation and its effect on the strain hardening behavior of austenitic stainless steel AISI 304 is studied [4]. Some austenitic stainless steels are prone to transformation from the metastable austenitic face-centered cubic structure to the more stable martensitic α' phase quadratic centered structure due to strain-induced martensitic transformation (SIMT) [5,6]. This strain-induced martensitic transformation enhances mechanical resistance and produce additional plastic deformation in the direction of the applied stress. In the present case, strain induced martensitic transformation was observed (Fig. 7) at the location of crack. The thickness of the material at the location of the crack was measured to be 0.4 mm against the raw material sheet thickness of 0.8 mm used for the fabrication of vibration isolator. This large deformation has produced strain induced martensitic transformation near to the location of crack.

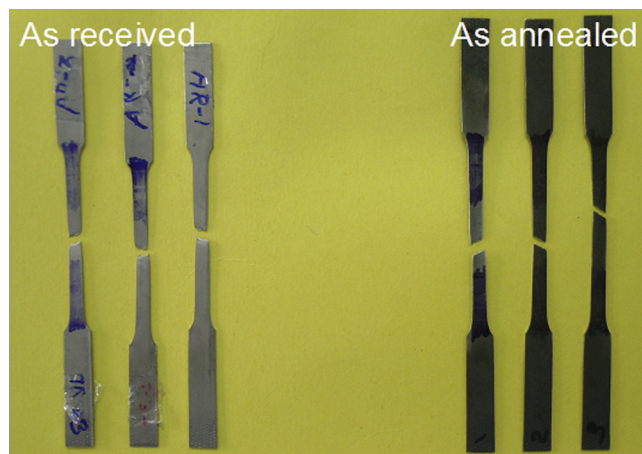
Tensile testing was performed on the raw material used for the fabrication of vibration isolators. The mechanical properties of the specimens are: 0.2% yield strength: 353 MPa; ultimate tensile strength: 741 MPa and % elongation of 65.6. The as received sheets were subjected to annealing at 1040 °C for 30 min and mechanical properties were evaluated. The mechanical properties of the specimens in the annealed condition are: 0.2% yield strength: 215 MPa; ultimate tensile strength: 672 MPa and % elongation of 73.4. The reduction in the yield strength and increase in elongation after annealing indicates that the original material is not in fully annealed condition. Fig. 7 shows the optical photomicrographs taken at the crack edge of the failed vibration isolator. Note the presence of deformation induced martensite and deformed grains in the radial direction taken at two different magnifications (a and b). Fig. 8 shows the photographs of the tensile tested coupons in the as received and after annealing at 1040 °C for 30 min. The surface of the material after annealing is characterized by a clear 45 degree fracture. Further, the higher elongation of the annealed specimens against the as received specimens can also be clearly seen in Fig. 8. Fig. 9 shows the stress–strain curves of the tensile tested coupons in the as received and after annealing at 1040 °C for 30 min. It can be clearly seen from the stress–strain curves that the yield and ultimate tensile strength of the material decreases and percentage elongation improves after annealing operation.

Fig. 8. Tensile tested coupons in the as received and after annealing at 1040 °C for 30 min. Note the higher elongation of the annealed specimens and 45 degree fracture against the as received specimens.

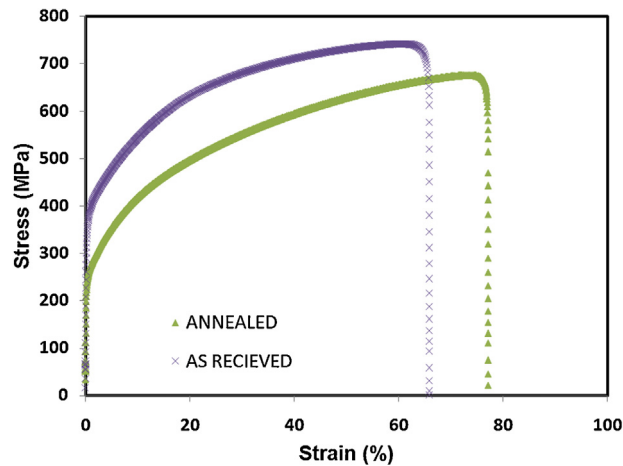
Fig. 9. Stress–strain curves of the tensile tested coupons in the as received and after annealing at 1040 °C for 30 min.
